# Manhole Inspection Summary

Manhole # S33E\_\_034MH

Insp Date: **8/1/08 10:35 AM**

**Location** Address: **222 liberty st**

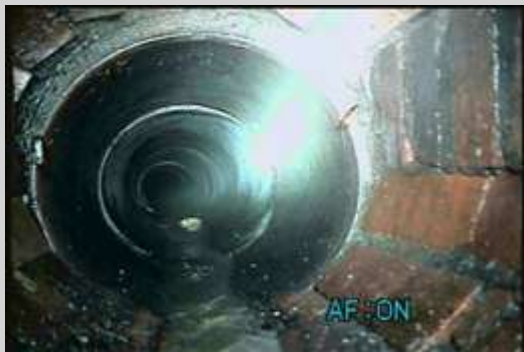
12 O'Clock Outflow

8 in. Circular Gravity Sewer  
Pipe Out @ 12 O'Clock

Pipe Material: **Clay** ☐ Pipe Lined

Invert Depth: **17.70** (ft.) Flow Characteristics: **Slow**

Infiltration: **None** Pipe Seal Cond: **Unknown**

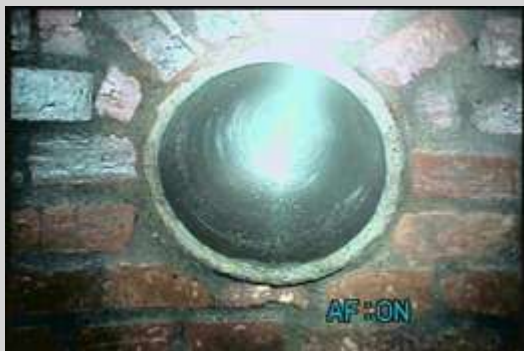
7 O'Clock Inflow

8 in. Circular Gravity Sewer  
Pipe In @ 7 O'Clock

Drop In @ 7 O'Clock

Pipe Material: **Clay** ☐ Pipe Lined

Infiltration: **None** Pipe Seal Cond: **Unknown**
